**Flood Control Project Maintenance
Levee Inspections**

Fall 2009 Levee Maintenance Deficiency Summary Report

San Joaquin River Basin

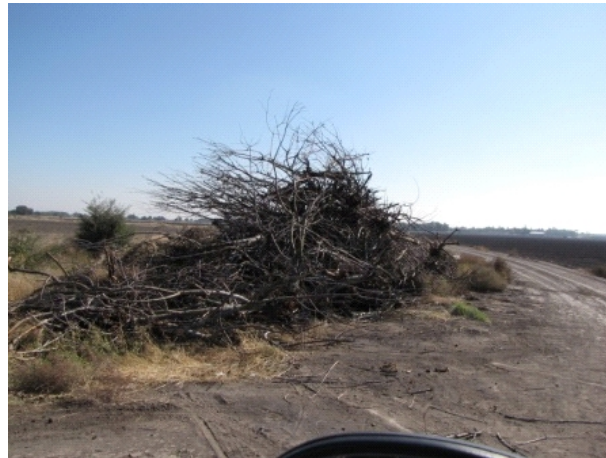
Levee Mile Report Line	2
Start Levee Mile	0.45
End Levee Mile	0.45
Location	Water Side
Category	Earthen Levee
Item	Encroachments

View of equipment on the waterward side of the levee looking upstream.

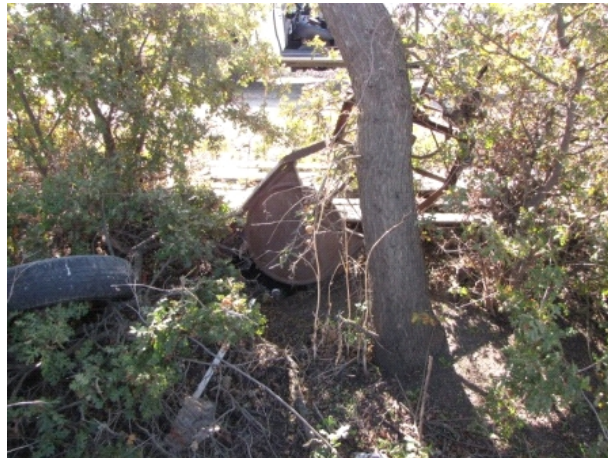
Levee Mile Report Line	5
Start Levee Mile	1.00
End Levee Mile	1.00
Location	Water Side
Category	Earthen Levee
Item	Trim / Thin Trees

View of tree branches blocking visibility and access on the waterward side of the levee looking upstream.

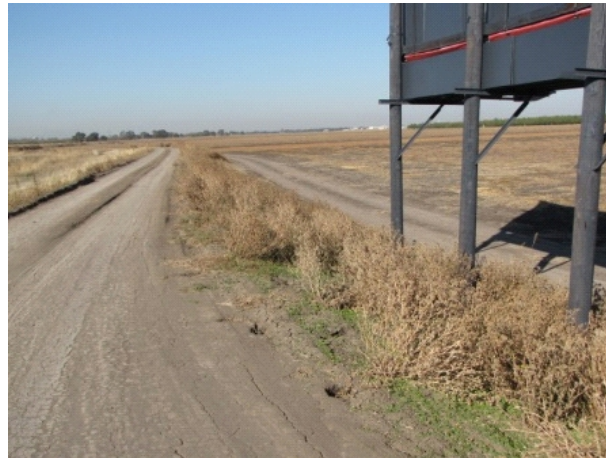
Levee Mile Report Line	2
Start Levee Mile	0.20
End Levee Mile	0.24
Location	Land Side
Category	Earthen Levee
Item	Vegetation

View of excessive vegetation blocking visibility and access along the landward slope looking downstream.

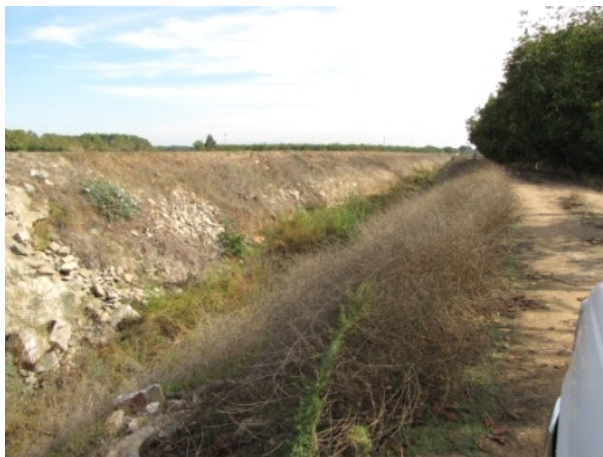
Levee Mile Report Line	3
Start Levee Mile	0.44
End Levee Mile	0.44
Location	Water Side
Category	Earthen Levee
Item	Erosion / Bank Caving

View of erosion significantly encroaching into the levee and access road looking upstream. Debris should be removed and a proper repair should be done.

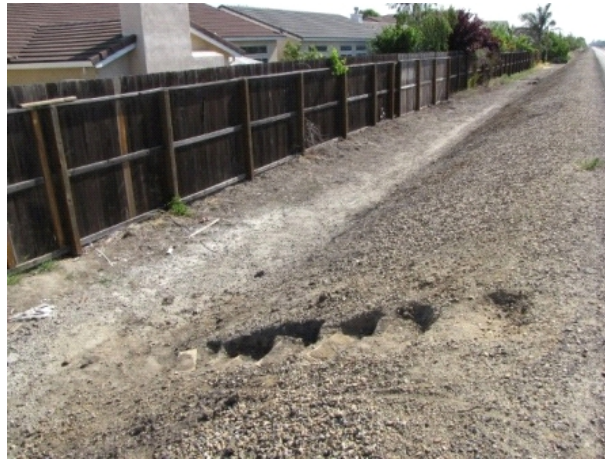
Levee Mile Report Line	10
Start Levee Mile	1.15
End Levee Mile	1.15
Location	Land Side
Category	Earthen Levee
Item	Encroachments

View of unauthorized steps dug into the landward slope looking upstream.

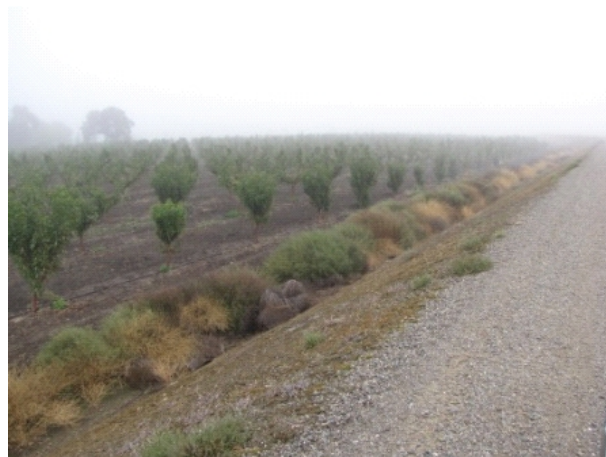
Levee Mile Report Line	74
Start Levee Mile	9.95
End Levee Mile	9.95
Location	Land Side
Category	Earthen Levee
Item	Erosion / Bank Caving

View of erosion occurring on a recent slope repair on the landward slope looking upstream.

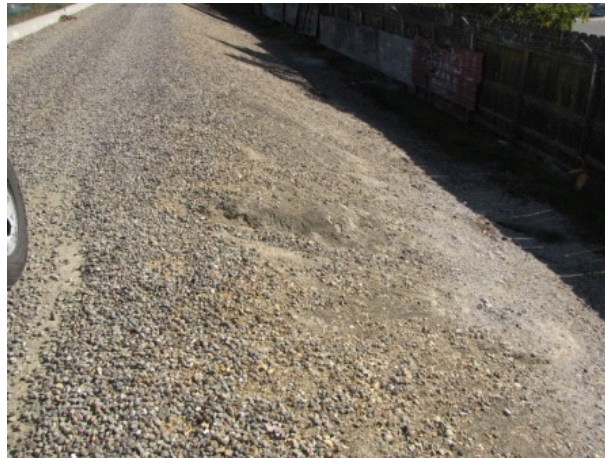
Levee Mile Report Line	44
Start Levee Mile	1.08
End Levee Mile	1.08
Location	Water Side
Category	Earthen Levee
Item	Animal Control

View of a depression likely caused by rodents in the waterward slope looking upstream.

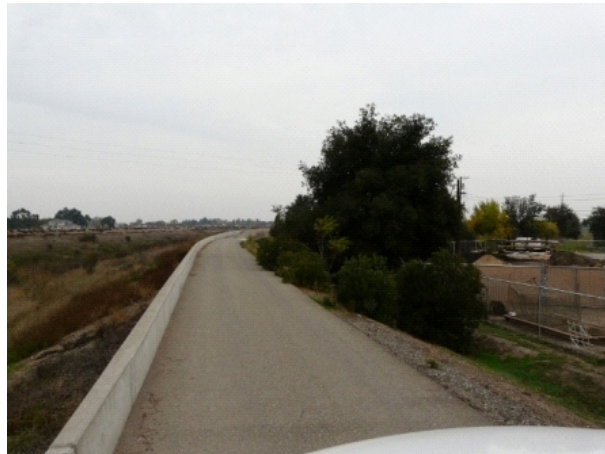
Levee Mile Report Line	139
Start Levee Mile	8.89
End Levee Mile	8.89
Location	Land Side
Category	Earthen Levee
Item	Slope Stability

View of the landward slope damaged by vehicular traffic looking upstream.

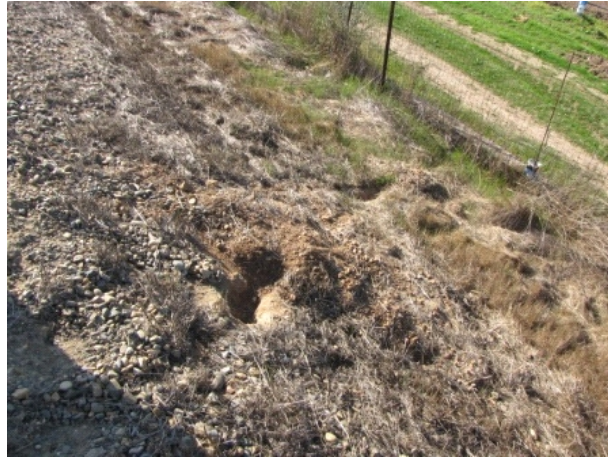
Levee Mile Report Line	5
Start Levee Mile	0.61
End Levee Mile	0.61
Location	Water Side
Category	Earthen Levee
Item	Encroachments

View of debris on the waterward toe and berm looking downstream.

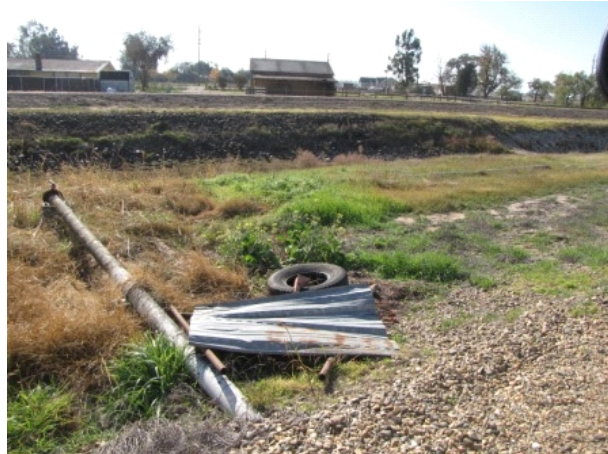
Levee Mile Report Line	6
Start Levee Mile	1.65
End Levee Mile	1.65
Location	Water Side
Category	Earthen Levee
Item	Vegetation

Example of condition of this levee. The unit is well maintained for vegetation.

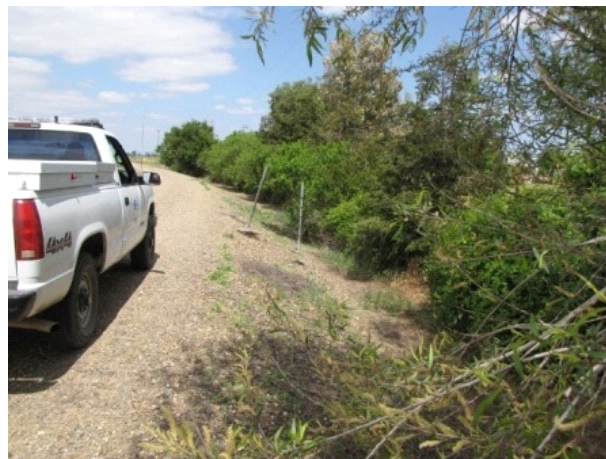
Levee Mile Report Line	2
Start Levee Mile	2.37
End Levee Mile	2.43
Location	Land Side
Category	Earthen Levee
Item	Encroachments

Updated view of landscaping as of fall 2009. The county has removed as much of the vegetation on the creek side of the fence as they can at this time.

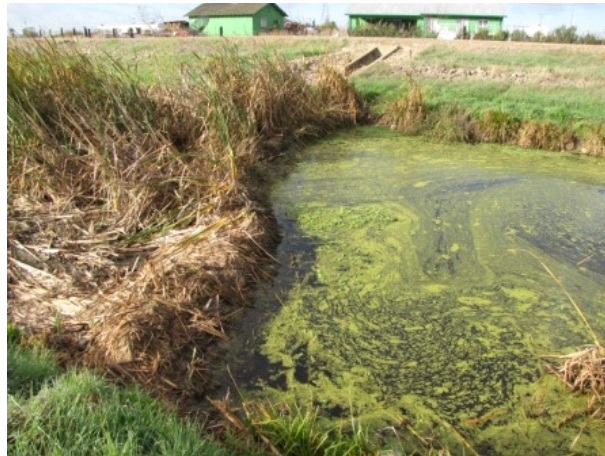
Levee Mile Report Line	4
Start Levee Mile	2.44
End Levee Mile	2.44
Location	Water Side
Category	Interior Drainage & Piping Systems
Item	Flap Gates

View of pipe and flap gate damaged and non-operational.

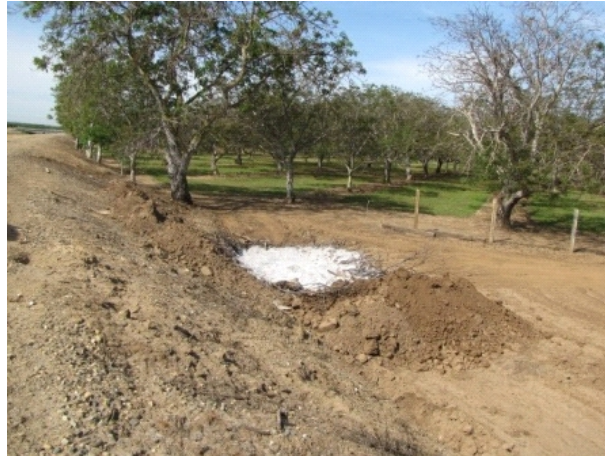
Levee Mile Report Line	10
Start Levee Mile	2.61
End Levee Mile	2.61
Location	Land Side
Category	Earthen Levee
Item	Slope Stability

View of farmer's excavation in the levee toe for a burn pile location looking upstream.

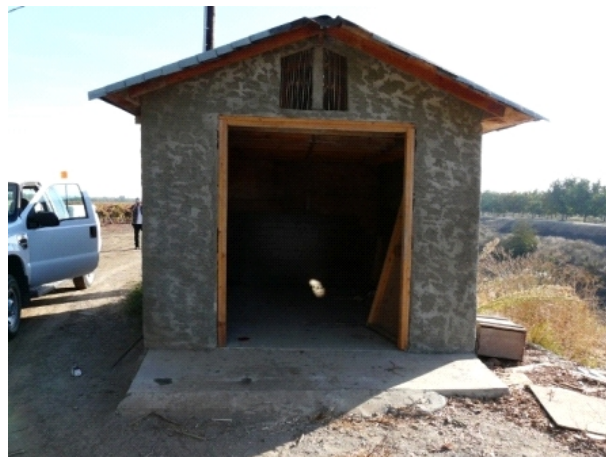
Levee Mile Report Line	93
Start Levee Mile	9.63
End Levee Mile	9.63
Location	Water Side
Category	Earthen Levee
Item	Encroachments
Additional view of building at LM 9.63.	
dpesaven_20091002_6.JPG

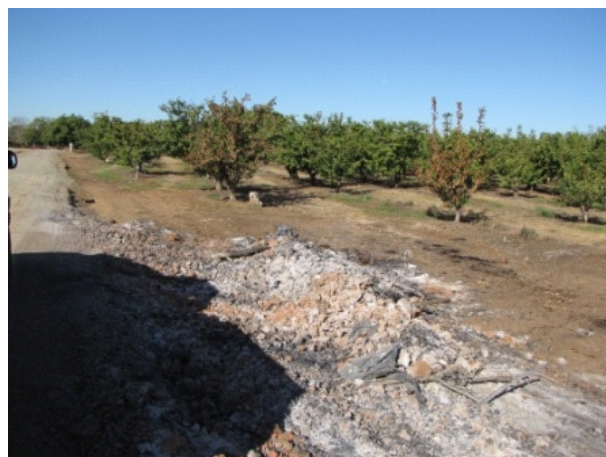
Levee Mile Report Line	100
Start Levee Mile	10.67
End Levee Mile	10.67
Location	Land Side
Category	Earthen Levee
Item	Encroachments
View of debris left from a burn pile on the landward side of the levee looking downstream.	
dpesaven_20091026_127.jpg

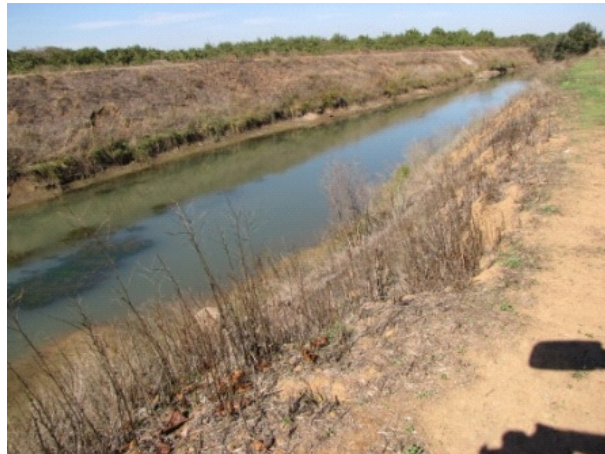
Levee Mile Report Line	13
Start Levee Mile	4.45
End Levee Mile	4.45
Location	Water Side
Category	Earthen Levee
Item	Erosion / Bank Caving
View of erosion on the waterward side starting to encroach into the access road.	
dpesaven_20091028_318.jpg

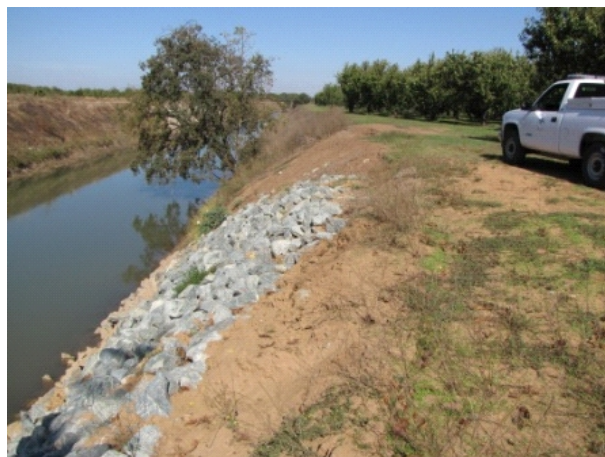
Levee Mile Report Line	15
Start Levee Mile	4.57
End Levee Mile	4.57
Location	Water Side
Category	Earthen Levee
Item	Slope Stability
View of repair location that has slipped down significantly looking upstream.	
dpesaven_20091028_316.jpg
